Structural Sewing Inspection Sheet - Maverick 2 & Vertesse Harness

This sheet refers to Maverick 2 and Vertesse Harnesses:

- HM102-S HW102-XS
- HM102-M HW102-S
- HM102-L HW102-M
- HM102-XL HW102-L

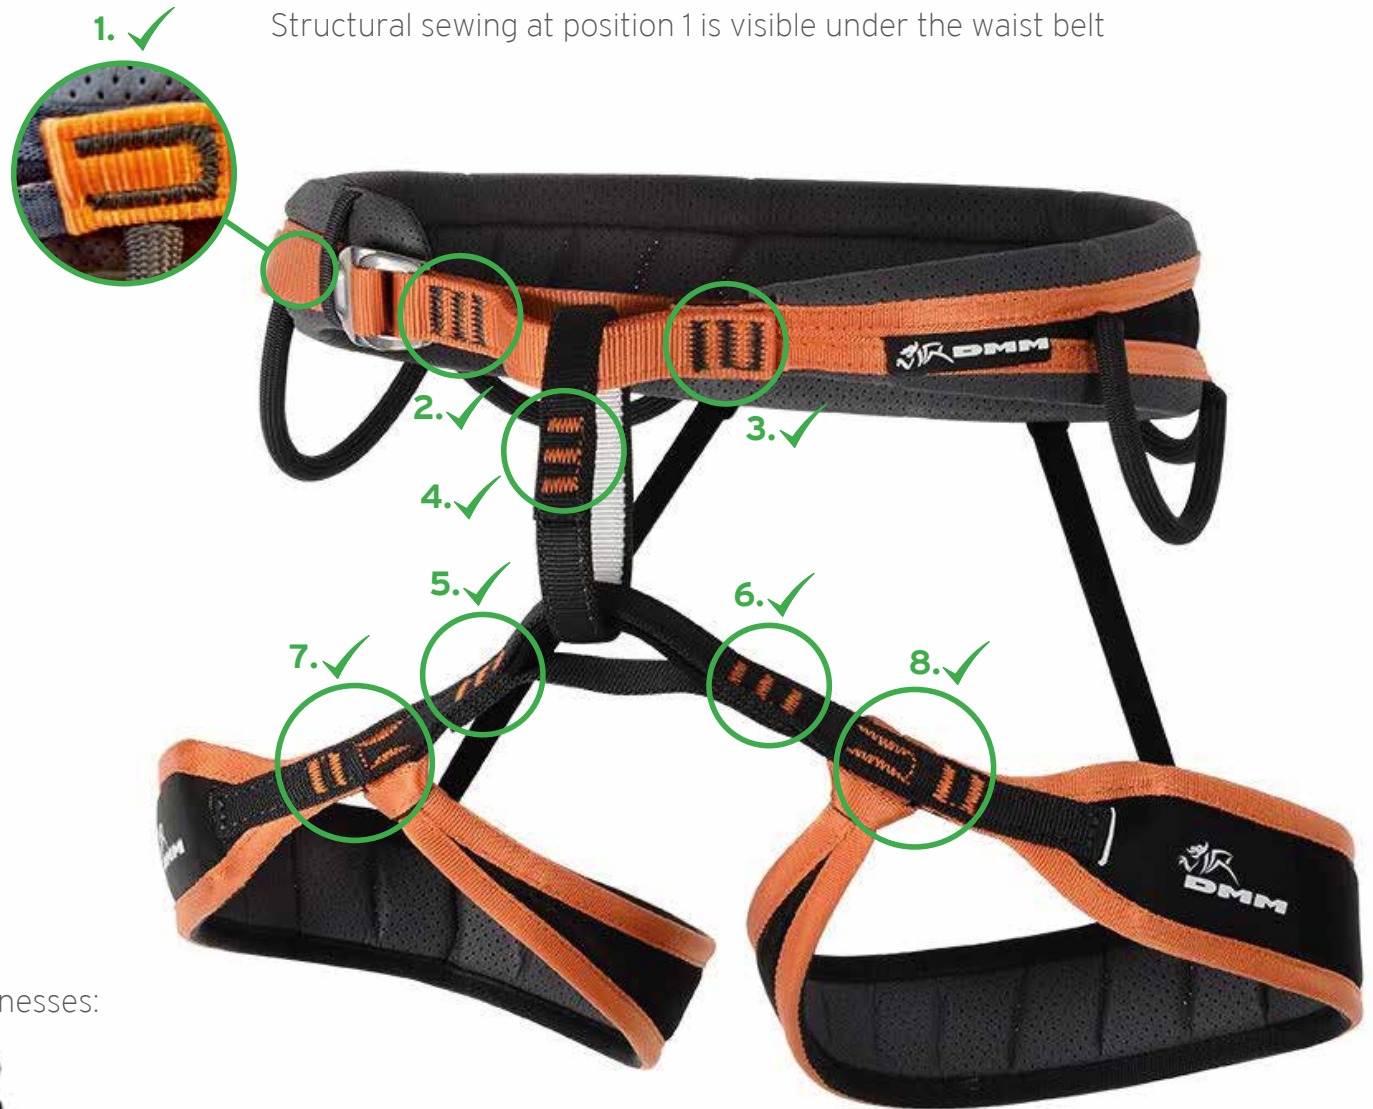
The image of the harness shows all structural sewing present and correct, highlighted by the green circles.

Structural sewing is always done in thread with a contrasting colour to the colour of the webbing.

Check your harness in the green circled areas on both sides of the webbing.

The red circle below shows an example of missing structural sewing.

If structural sewing is missing stop use and contact DMM:
